Manhole Inspection Summary

Manhole # S19K1_030MH

Insp Date: **5/6/08 10:19 AM**

Location Address: **3118 savoy st**

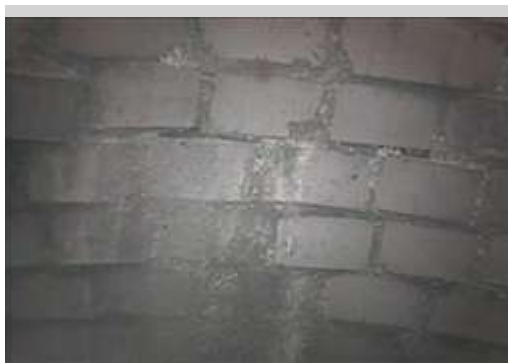
Defect 4

Infiltration: ☐ None ☐ Joint ☐ Cracks ☐ Mortar ☐ Roots ☒ **Wall**

infiltration @ corbel wall

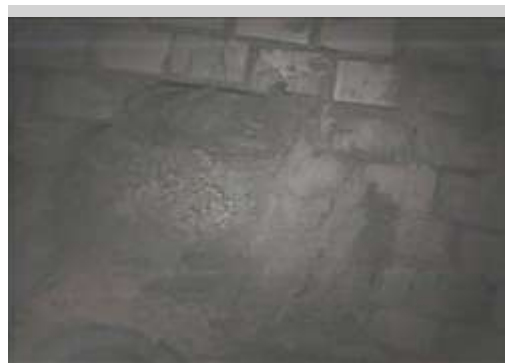
Defect 3

Infiltration: ☐ None ☐ Joint ☐ Cracks ☐ Mortar ☐ Roots ☒ **Wall**

infiltration @ barrel wall from missing brick

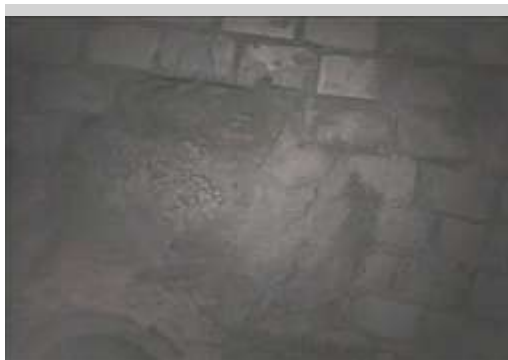
Defect 2

Condition: ☐ Sound ☐ Cracked ☐ Root Intrusion ☒ **Loose Brick** ☐ Deteriorated

loose/missing barrel brick

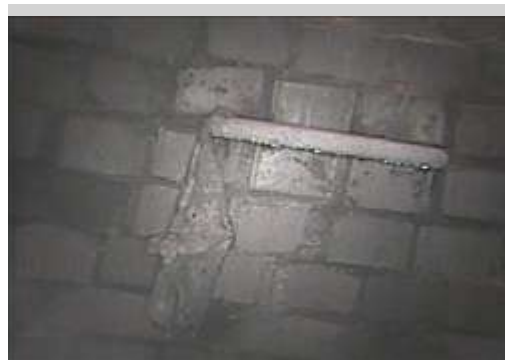
Defect 1

Surcharge ☒ **Evidence Of Surcharge** Depth: **3** (ft.) ☐ Active Surcharge Present

surcharge evidence

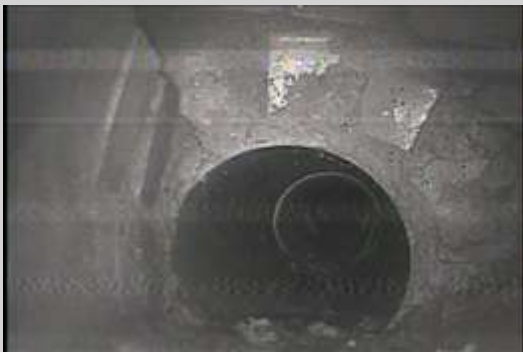
12 O'Clock Outflow

Pipe Height: **8.4** (in.) Rod and Bar (Angled)
Pipe Material: **Clay** ☐ Pipe Lined
Invert Depth: **9.64** (ft.) Flow Characteristics: **None**
Deposits: ☐ None ☒ **Mud** ☐ Sludge ☐ Debris ☐ Grease
Silt Depth: **1** (in.) Deposits Extent: **Light**
Infiltration: **None** Pipe Seal Cond: **Sound**
